INDUCOR INGENIERIA HAS BEEN APPOINTED BY ENDESA CHILE TO CARRY OUT THE FAULT LOCATION TESTING ON THE TURBO GENERATOR OF BOCAMINA I

Concepción - Chile - April 2011:

ENDESA CHILE - GENERADOR CENTRAL TERMICA BOCAMINA 1

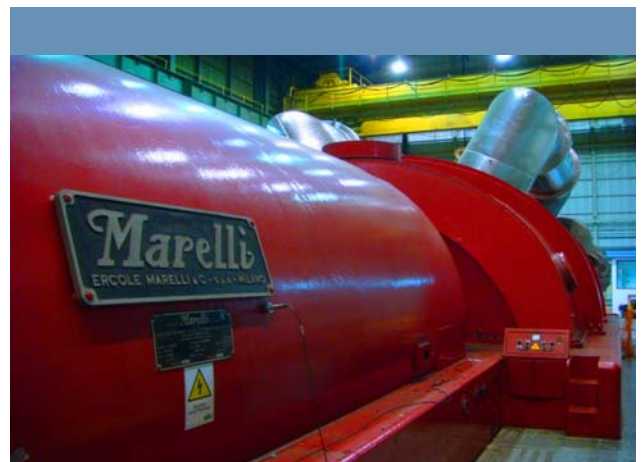
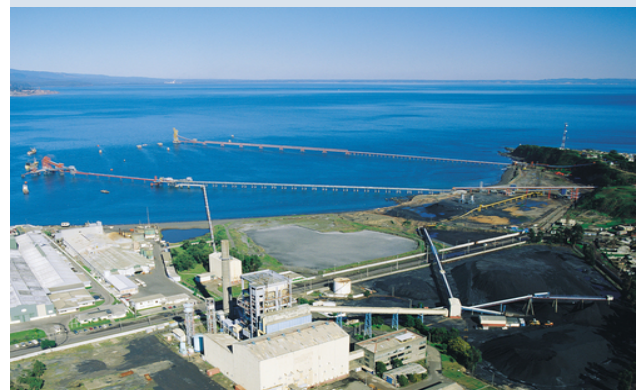
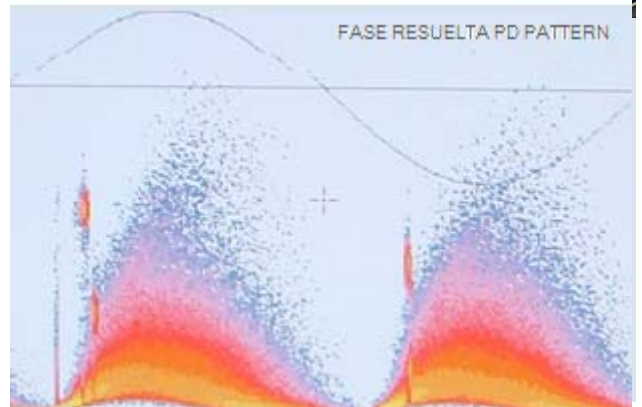
After the series of 8.8 scale earthquakes occurred on February 2010 in Chile, and being the attractive coastal city of Coronel (Bio-Bio Region), one of the most affected by the tsunami effects, the main turbo-generator of Bocamina 1 Thermoelectric Plant, has presented irregularities during the three last commissioning testing.

With a 147 MVA installed power (13,8 KV) and 43 years (1968), the old but reliable Italian thermal machine, presented perturbances in different progress stages.

After 96 hours of intensive testing, which included Phase Resolved Partial Discharge Analysis, in different states of process, and in OFF-LINE condition, (and in complementary way: Dissipation Factor - Static and Dynamic Impedance - RSO – Surge Tester - among others), the causes of the irregularities have been detected and expressed in the respective reports.

The successful and reliable performance that the Ercole Machine (from Bocamina 1 Thermoelectric Plant) had for several years will have to pass necessarily and in short time, by a stage of internal controls and corrections.
